HILFIKER RETAINING WALLS

MSE WALL MAINTENANCE AFTER INSTALLATION

DAMAGE TO WALL FACE AFTER INSTALLATION

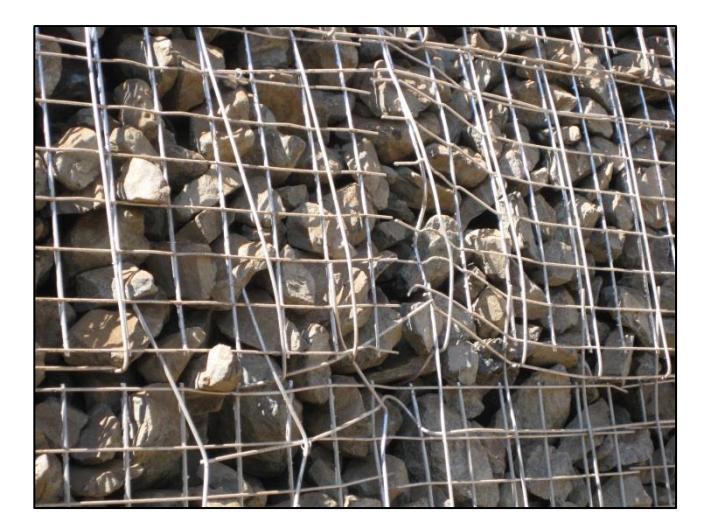
As an owner, you don't like it, and as a manufacturer, we don't like to see something like this happen to the face of our wall... But it happens and now you need some guidance (from the material manufacturer) as to how best to repair the damage and stop any further raveling of the wire face.

Damaged Wall Face

Typical repair recommendations for a situation such as this would be:

- Attempt should be made to straighten any bent wires, without breaking them.
- Confinement of the undisturbed backfill material is a priority. Do not allow any wash down procedure to occur in this area. Keep surface water away to prevent the loss of any more fill.
- Repairs that would fill the void could include the placement of shotcrete or hand-packed mortar, or forming the face and filling the void with lean concrete, cellular concrete, foam or a similar material.
- Finally, some wire of similar coating could be 'patched' over the damaged area.

However, in some cases, the Engineer for the wall design may also need to review the damage and provide their recommendation along with their assessment for the structural integrity of the wall. Hilfiker can assist in providing our consulting Engineer's input, if the design was provided from Hilfiker initially.

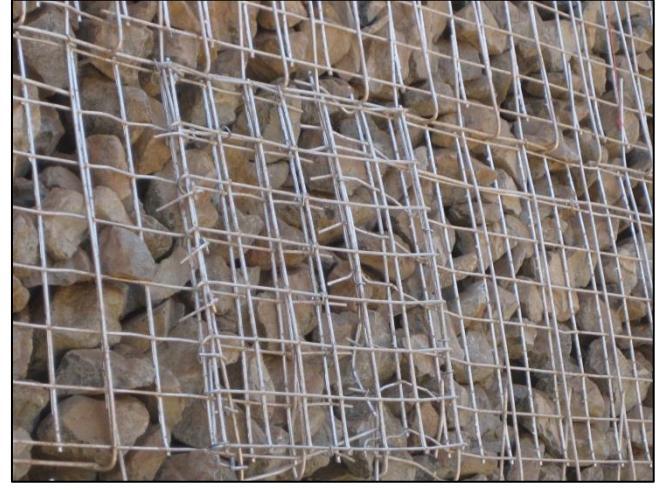
Patched with Wire
